Preventative Maintenance

Check the alignment of the crystal head contact springs and backing plate

J19991-62

W800

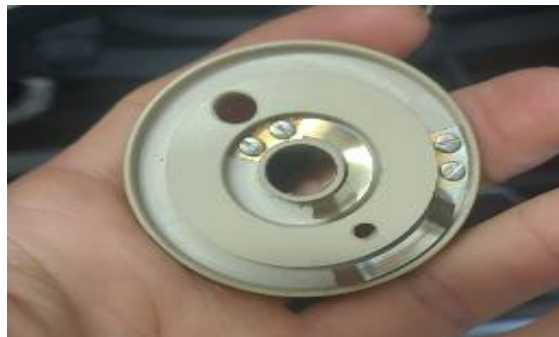
3 Visually inspect the crystal cassette contact springs for any sign of damage

Each contact strip should have a single upward bend and also a downward kink at the end.

The spring shown in this picture has multiple bends and will not work correctly

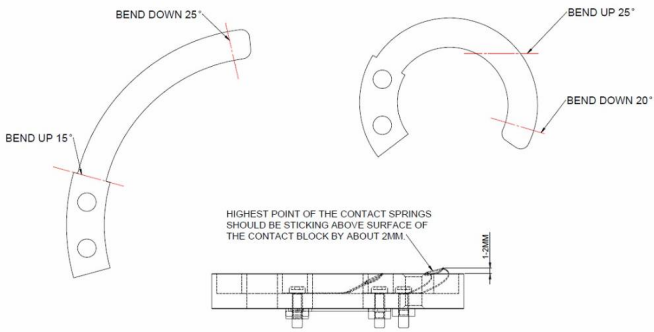
4 Correctly adjust the bend of the crystal contact strip.

Refit the contact strip backing plate into its recess evenly.

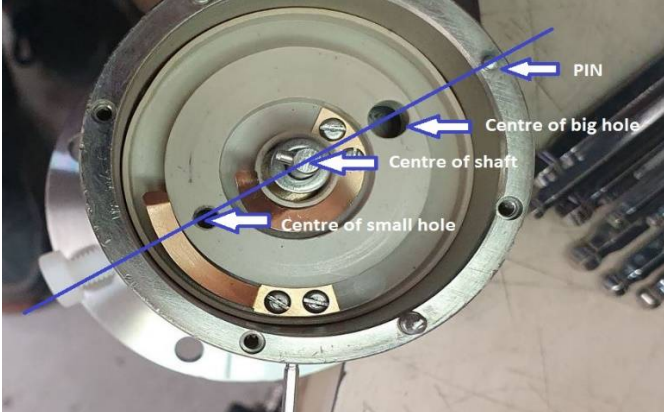
5 Correctly adjust the rotational alignment of the crystal spring backing plate and tighten the grub screws

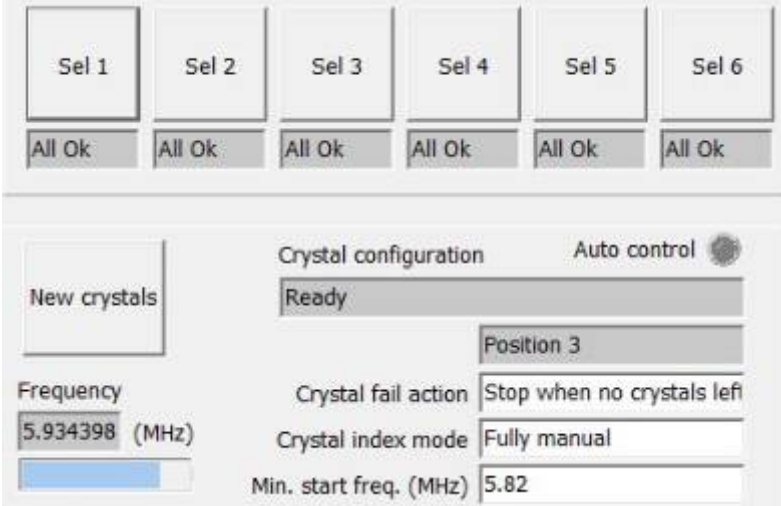
6 Refit the crystal cassette and front cover. Press "new crystals" to cycle through the 6 crystal positions to ensure each has good crystal alignment and that there is activity on the sensor.
